# NATIONAL TRANSPORTATION SAFETY BOARD

## AIRCRAFT ACCIDENT REPORT

PROVINCETOWN-BOSTON AIRLINES  
FLIGHT 1039  
EMBRAER BANDEIRANTE, EMB-110P1, N96PB  
JACKSONVILLE, FLORIDA  
DECEMBER 6, 1984

NTSB/AAR-86/04

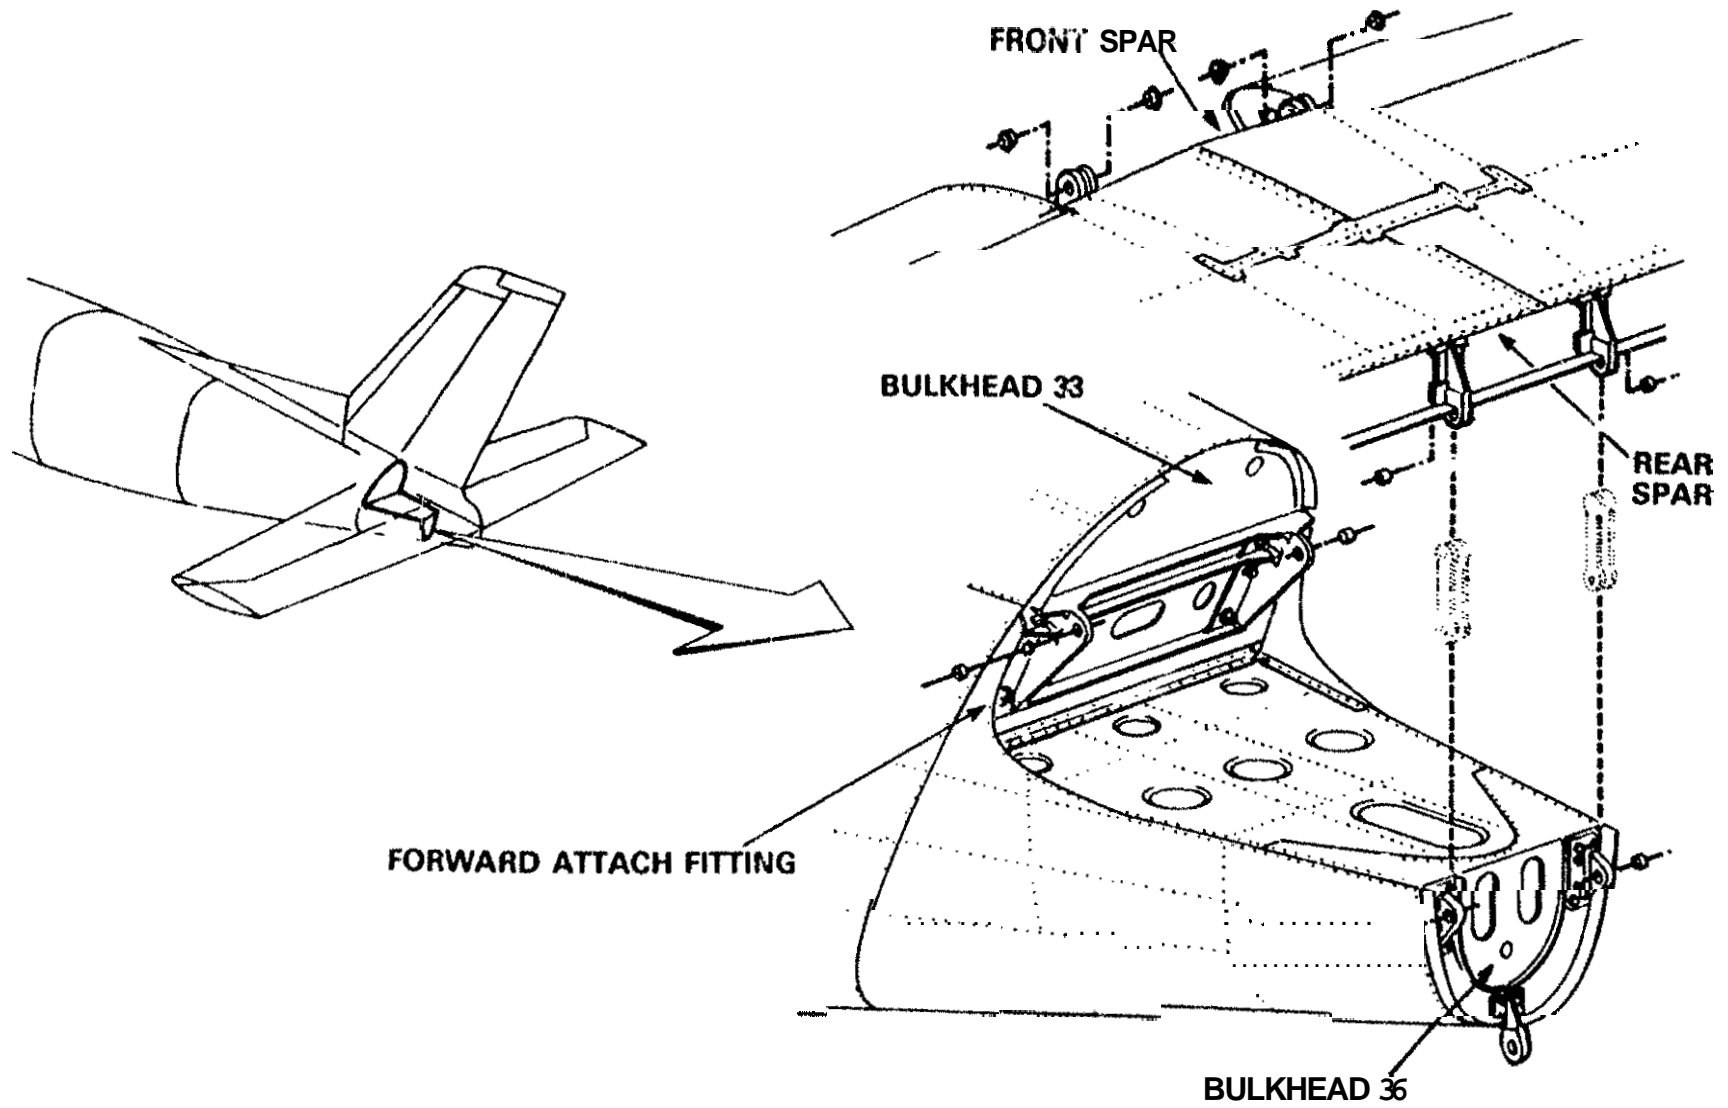
Figure 1.—Bandeirante EMB-110P1 stabilizer/fuselage supports.

The examination of the bulkhead No. 33 structure disclosed fretting around some rivet holes in channels which transmit the loads from the upper right corner of the forward attachment fitting into the fuselage structure forward of the bulkhead. The bulkhead web break contained a small preexisting fatigue crack, 5/16 inch long.

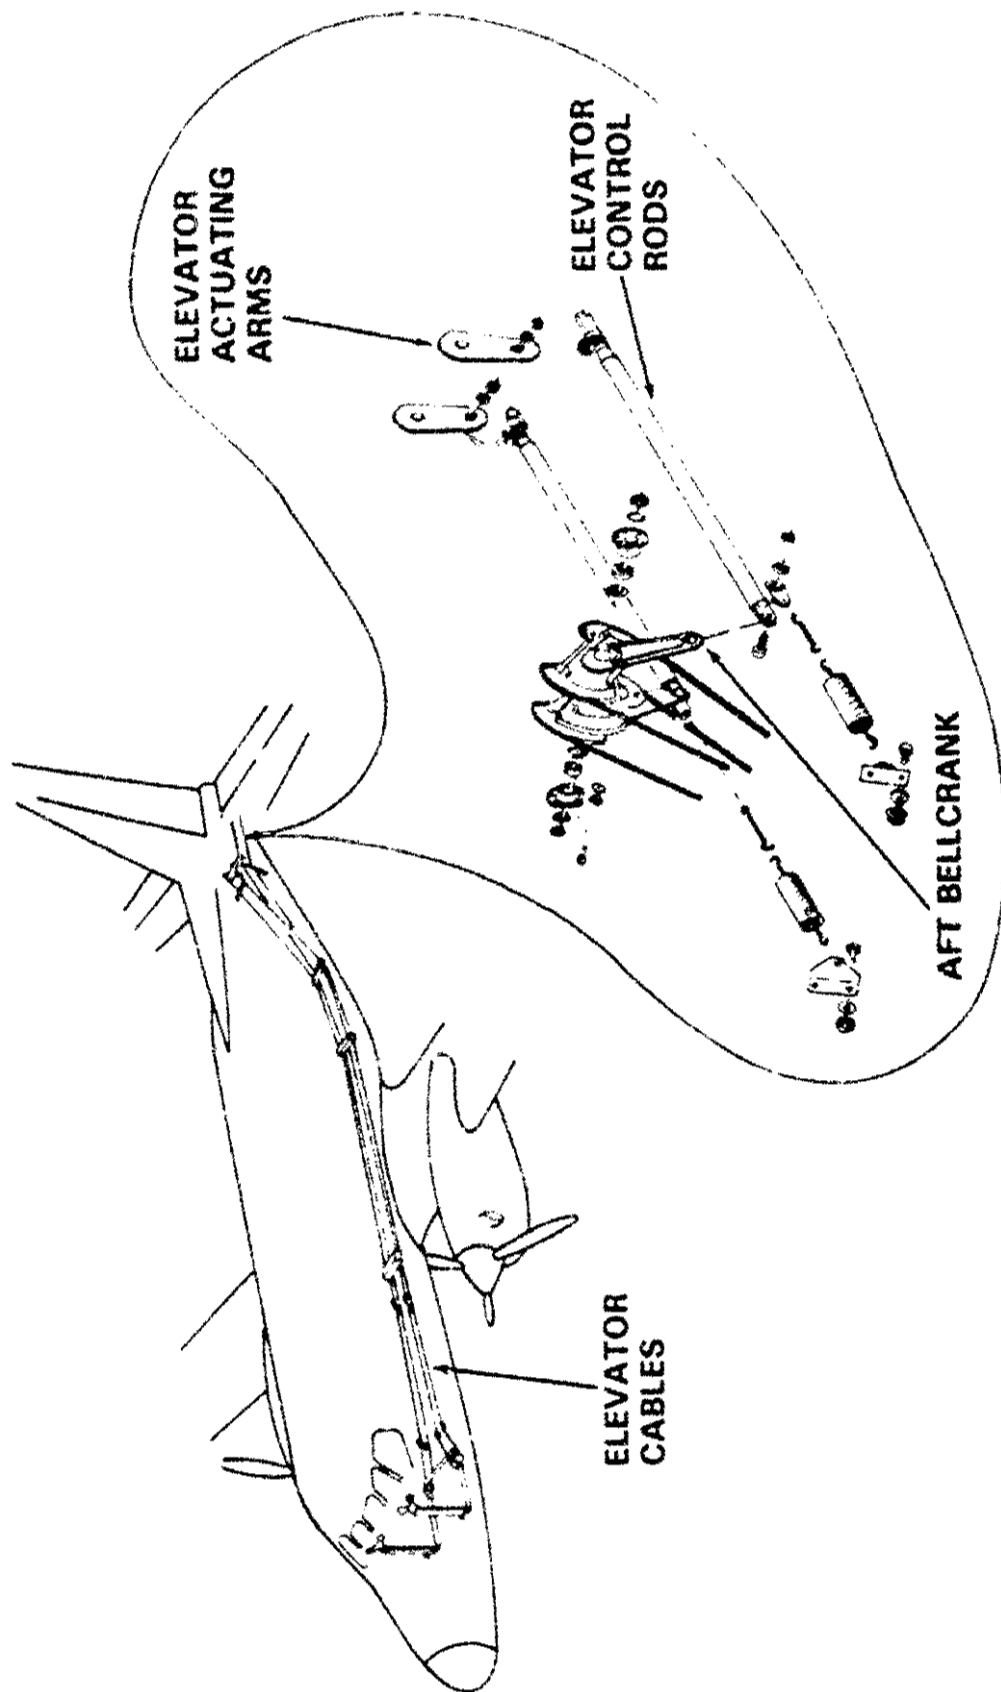
Figure 5.—Pandeirante EMB-110P1 elevator control installation.

The elevator control system of the EMB-110P1 airplane is redundant and consists of the captain's and first officer's control columns, which are interconnected, and independent bellcrank-cable-pulley systems on each side of the airplane. (See figure 5.) The movement of either control column will transmit motion through both cable systems to two aft bellcranks mounted on the forward face of fuselage bulkhead No. 33. These aft bellcranks also are interconnected and they transmit motion through the left and right elevator control rods respectively to the elevator actuating arms which rotate the elevators about their stabilizer hinges. The left and right elevator actuating arms are not interconnected.

As a result of the crash, the captain's control column was found detached from the cockpit floor mounting and no elevator control interconnect components were attached to the column. No scoring or impact marks were observed on the control column attachment surfaces at the points where it contacted the forward and aft travel stops. The first officer's control column was found connected to the cockpit floor mounting. It moved freely from the aft travel stop to the forward travel stop. Both travel stops were wired in place, and there was no evidence of impact with the column. The forward elevator control rod was found attached at its correct location between the first officer's control column and the elevator bellcrank. One control column-to-bellcrank cable had not separated from the turnbuckle, and the safety clip was still in place. However, the other control column-to-bellcrank cable appeared to have been cut about 3 feet from the forward bellcrank. The control rod between the captain's and the first officer's elevator bellcranks was severed about 3 inches from the first officer's bellcrank. Both control columns were bent aft and downward about 12 inches below the yoke attachment bolt.

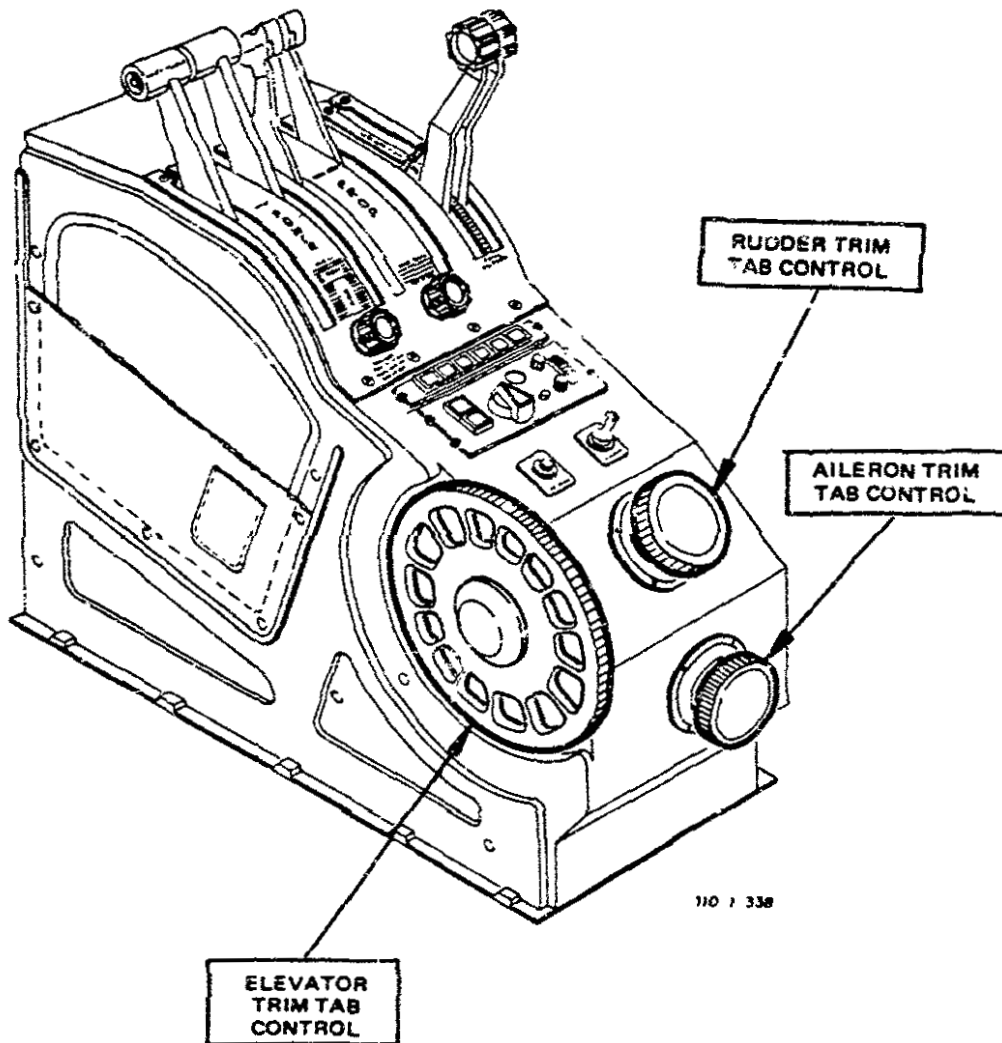
Figure 7.—Trim tab controls.

The pitch trim in the EMB-110 is effected by deflection of the single trim tab on the trailing edge of the left elevator. The elevator trim tab deflection is accomplished either mechanically, by rotating a trim wheel located on the pilot's side of the center pedestal (see figure 7), or electrically, by activating switches on either of the control wheels. Both methods effect a linear movement of a threaded cable through a coaxial housing, which in turn extends or retracts the trim tab linear actuator rod through a gear type mechanism. The deflection of the trim tab relative to the elevator surface is directly related to the position of the linear actuator rod. (See figure 8.)

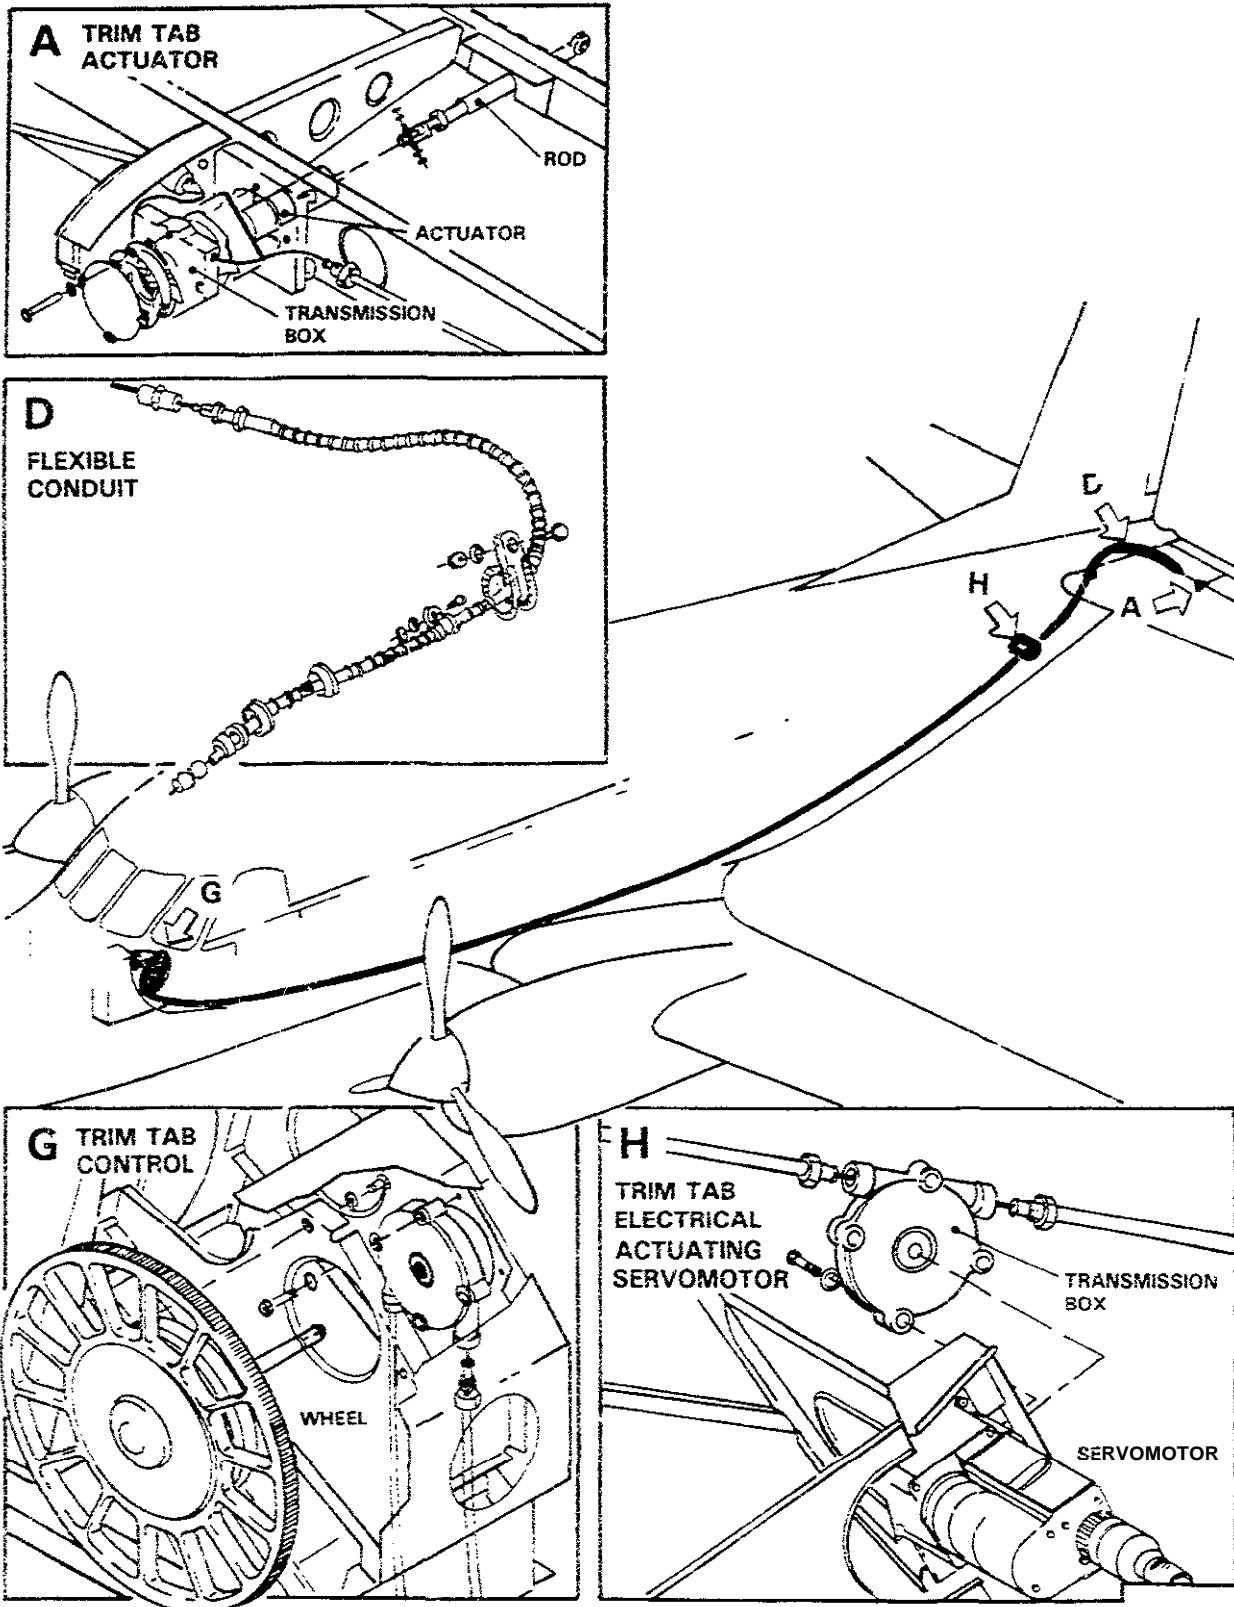
Figure 8.—Bandeirante EMB-110P1 trim tab actuator assembly.

The elevator trim tab **was** attached to the elevator. Although the piano type hinge wire was deformed, measurements of the hinge **and hinge** wire indicated that there was no excessive free play. The trim tab actuator housing remained attached to **the** left elevator spar. The actuator rod was fractured between **the** actuator **and** the rod end which remained attached to the trim tab bellcrank. The overstress bending fracture and deformation of the actuating rod matched the damage **on the** elevator rear spar structure through which the rod passes. The matching damage indicated that the actuator rod was fully extended when it struck the rear spar. The fully extended position of **the trim** tab actuating rod corresponded to a trim tab trailing edge up deflection (full airplane nose down trim).

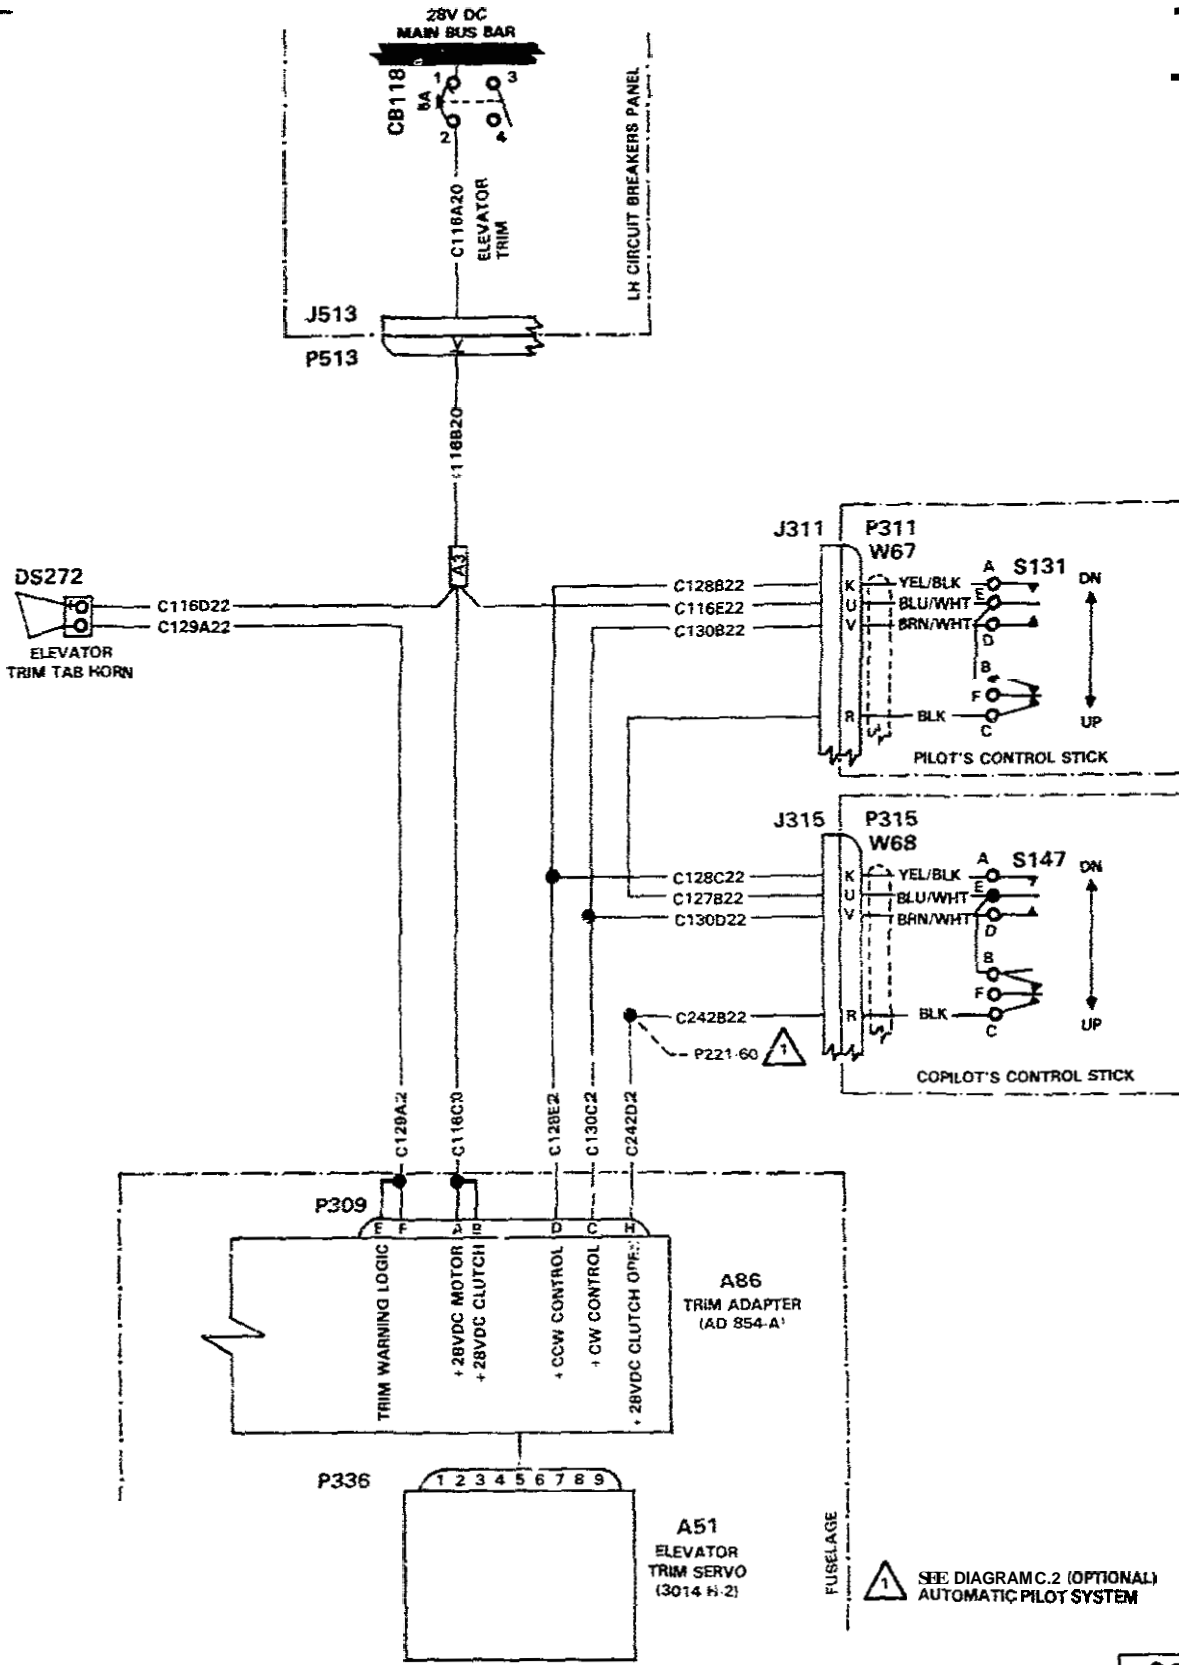
Figure 9.--Elevator trim system wiring diagram.

terminal "E" of the captain's trim switch and shorting of the broken off wire to terminal "A" or terminal "D" of the switch. (See figure 9.) This same failure of the first officer's control wheel mounted trim switch also would produce an uncommanded operation of the trim system; however, the operation of the system would be interrupted by any trim selection at the captain's switch. One of PBA's EMB-110P1 captains testified that he did not remember receiving any training for a runaway trim emergency. He did not know the location of the trim circuit breaker.

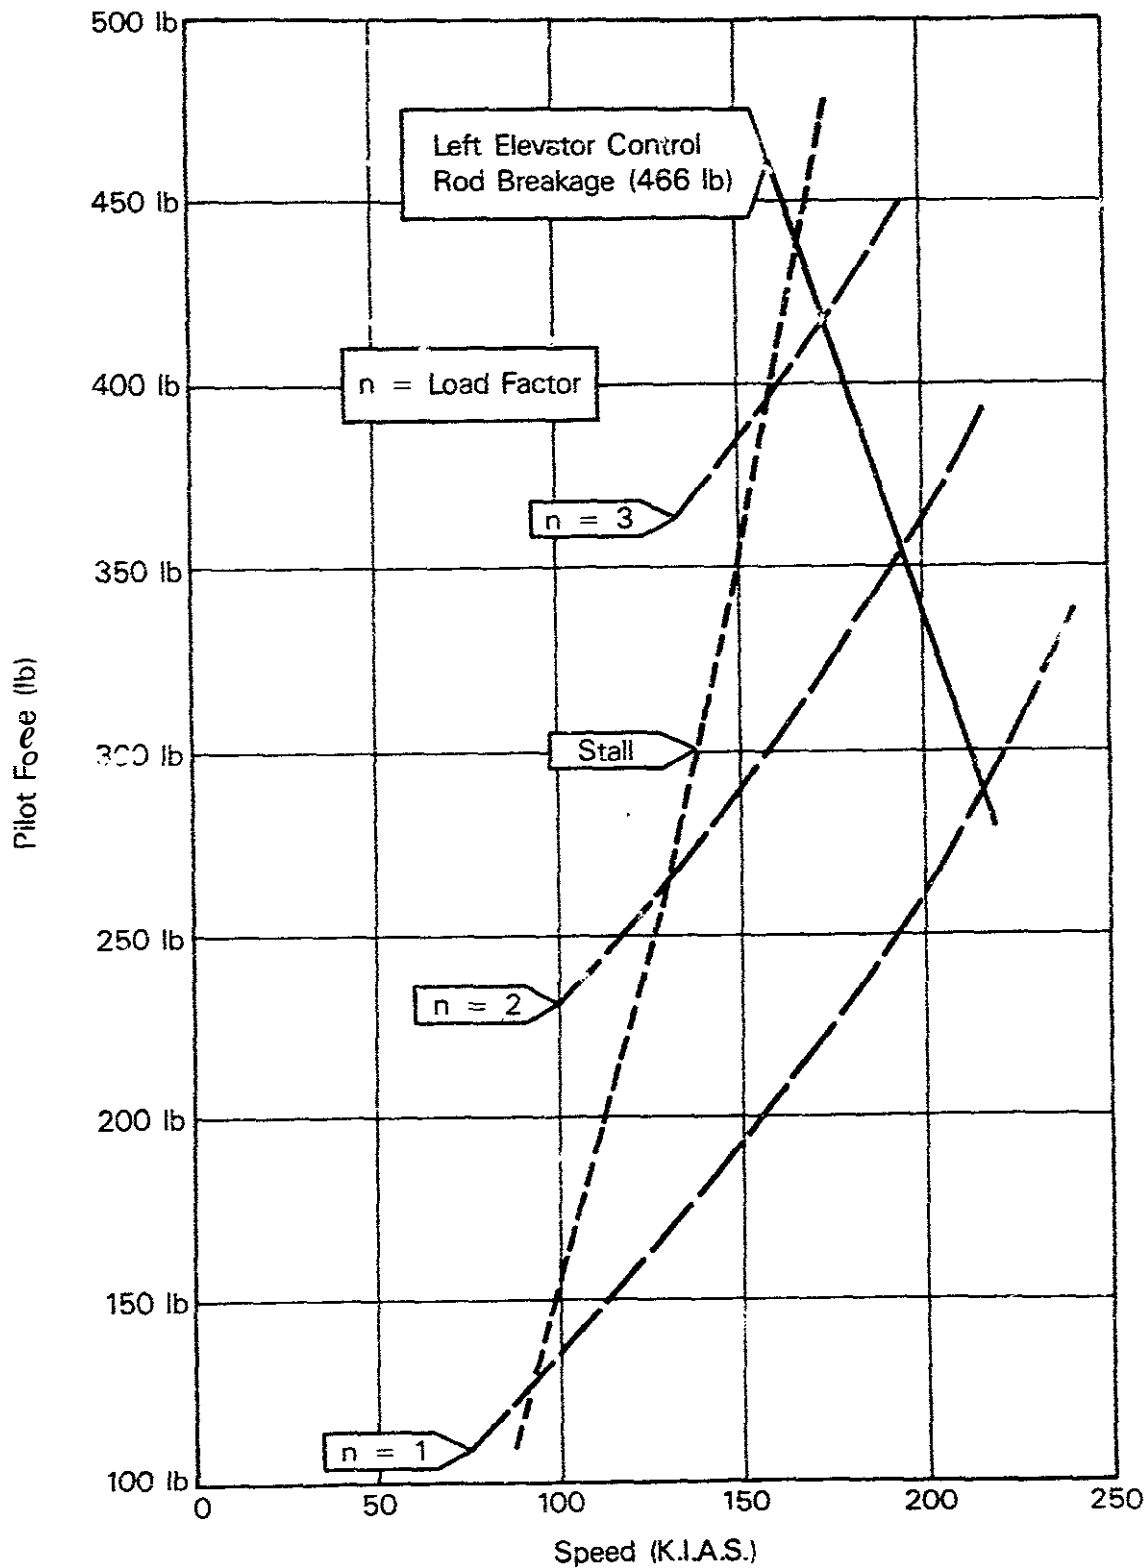
Figure 10.—EMB-110P1 pilot force versus speed.

In response to a Safety Board request, the airplane manufacturer analyzed the envelope of conditions--pilot force, airspeed, and normal load factor--that will result in a 466-pound compression load in the left elevator control rod. The assumptions for the analysis were that the weight and c.g. location were as they existed during the accident and that the elevator trim tab was fully deflected with the trailing edge upward. The full trailing edge up trim tab would result in the highest compression loading of the left elevator control rod for a given pitch-up maneuver. The plot of pilot force versus airspeed shows the pilot force and normal load factor which would be required at a given airspeed to produce a 466-pound destructive compression load in the left elevator control rod. (See figure 10.)

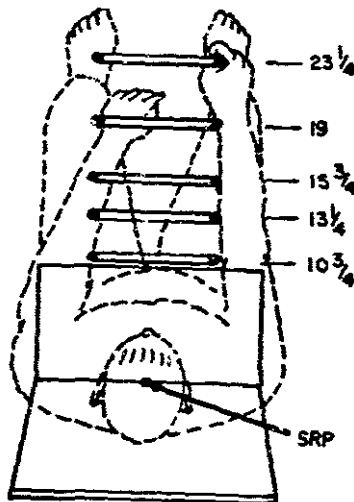
Figure 11.—Maximal static force exerted on an aircraft control stick by seated males.

figure 11. The design criteria for limit control forces specified for compliance with Federal Aviation Regulations Part 23.397(b) for an airplane weighing 13,000 pounds is 238 pounds for an elevator control wheel.
